Property Inspection Report

Date of Inspection: 1/3/2021

Report# SAMPLE010321

**1234 Some St
City, CA. 12345**

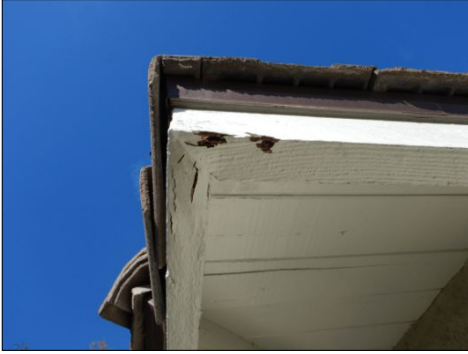
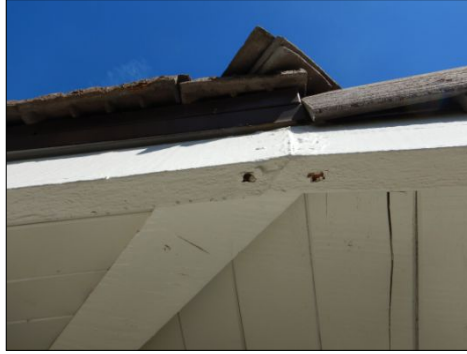
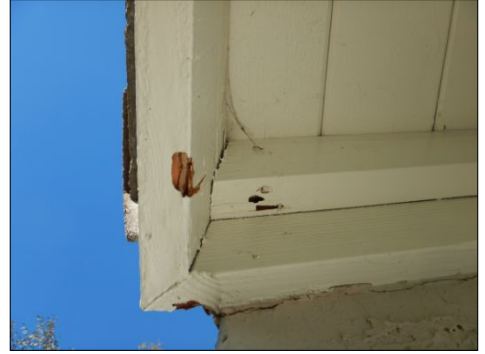
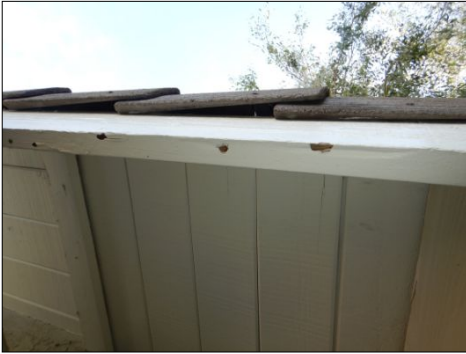
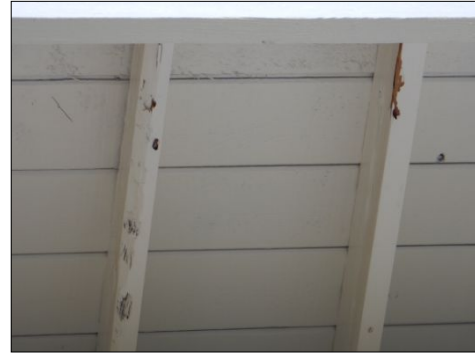
Eaves, Fascia, & Trim

Signs of wood destroying pest/organisms noted at the trim; we recommend further evaluation and corrections by a licensed pest control operator prior to removal of any contingencies.

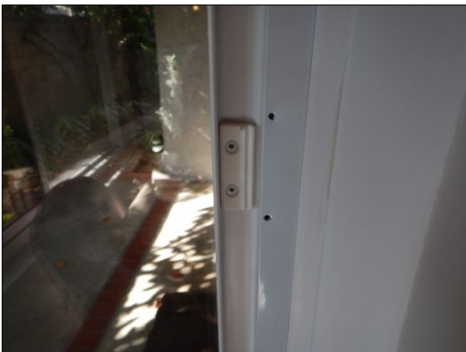
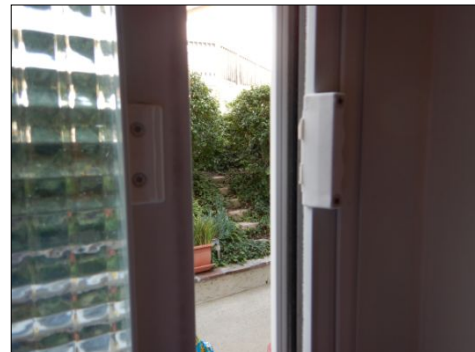
Retractable screens were installed. This type of screen is known to be problematic. Future repairs should be expected.

A number of the screen latches were missing or damaged. We recommend further evaluation and correction.

Suggest complete review/correction including cost estimate (bids) by a qualified licensed general contractor before the end of the contingency period.

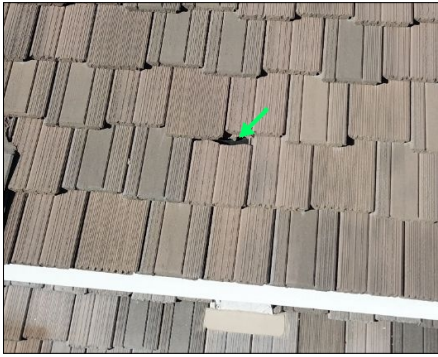
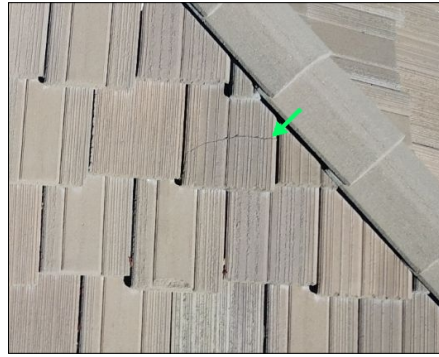
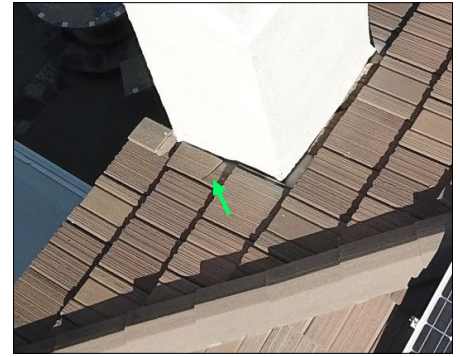
Surface Condition

Visual inspection of the roof covering revealed that a solar power system has been installed on the roof. A complete and thorough visual inspection of the roofing system could not be conducted. It is recommended that a state licensed roofing contractor be retained for a thorough inspection of the roofing components beneath the solar panels before the close of escrow.

Cracked tiles were found, cracked tiles should be replaced as they can lead to leaks. Corrections are recommended.

Suggest complete review/correction including cost estimate (bids) by a qualified licensed roofing contractor before the end of the contingency period.

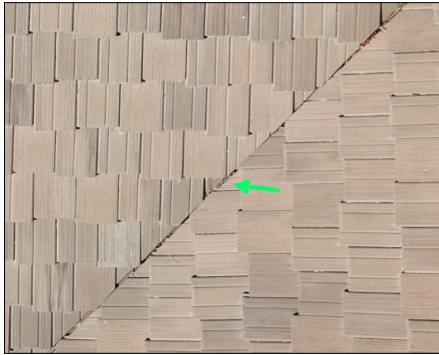
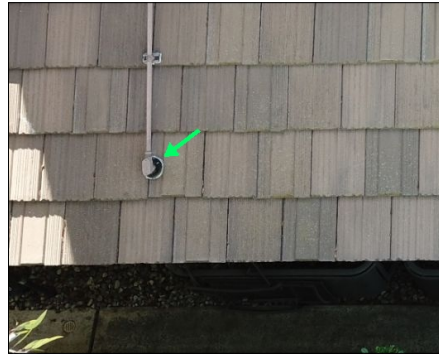
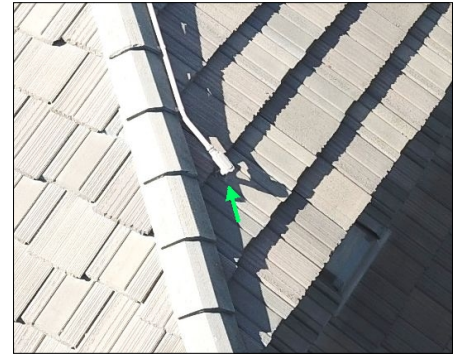
The solar conduit penetrates the roof without approved flashings, this can be a source of leaks, we recommend further evaluation and correction.

There was a build up of debris in the roof valley(s). We recommend the debris be removed and the areas inspected and maintained regularly.

Suggest complete review/correction including cost estimate (bids) by a qualified licensed roofing contractor before the end of the contingency period.

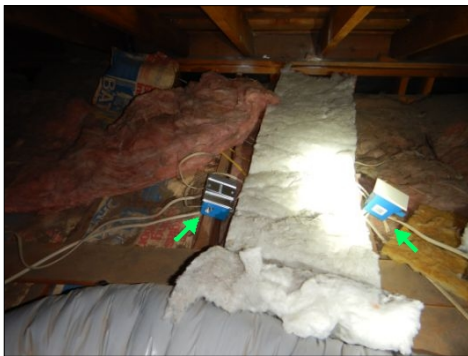
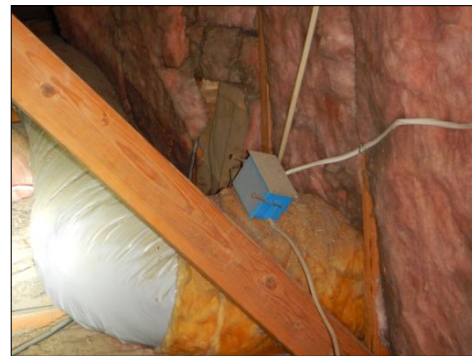
There are unsecured junction boxes in the attic, we recommend they be secured to the framing to prevent damage or injury.

Suggest complete review/correction including cost estimate (bids) by a qualified licensed electrical contractor before the end of the contingency period.

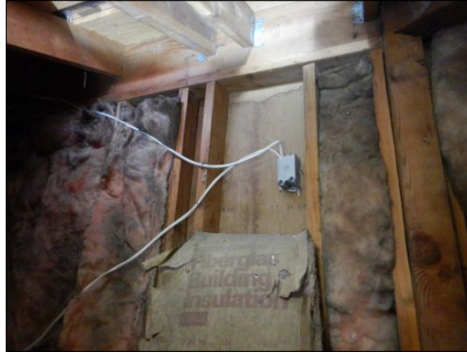
Attic Insulation Condition

The attic insulation was displaced in a number of areas and is not providing the intended R-Value, we recommend evenly disbursing the insulation.

The attic access cover was missing the insulation, we recommend installing insulation on the access cover for increased energy efficiency.

For attention to the condition(s) noted, and/or cost estimates, if necessary, we recommend the advice and services of a general contractor.

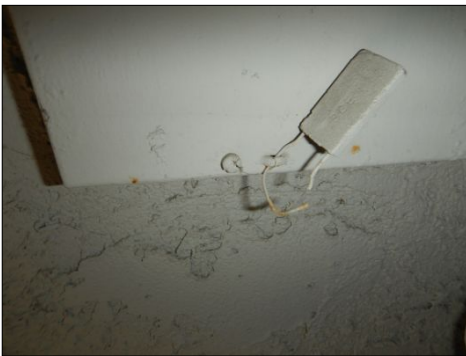
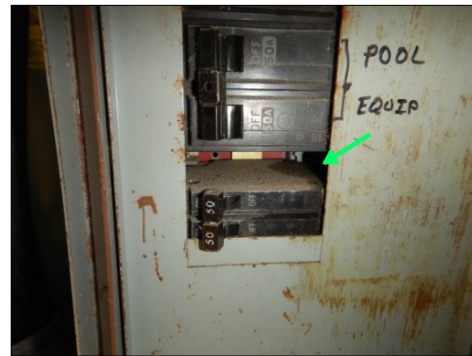
The utility seal was cut at the service cable entrance to the panel. We recommend contacting the utility for replacement. Note: Often times this is a free service.

There are open slots in the service panel cover. This increases the likelihood of persons contacting the "live" electrical components within the panel. We recommend installation of approved filler plates to replace the missing twist outs.

Suggest complete review/correction including cost estimate (bids) by a qualified licensed electrical contractor before the end of the contingency period.

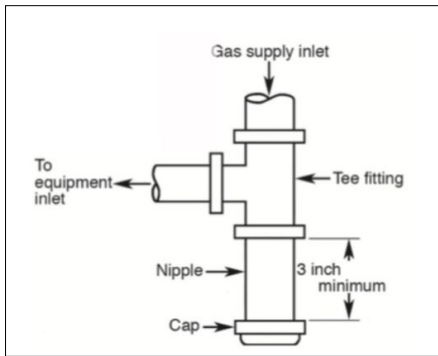
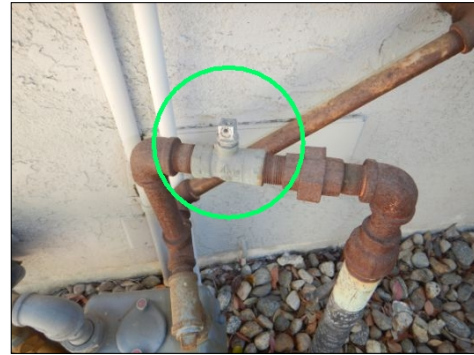
The shut off valve near the meter was missing the handle, replacement is recommended.

Suggest complete review/correction including cost estimate (bids) by a qualified licensed plumbing contractor before the end of the contingency period.

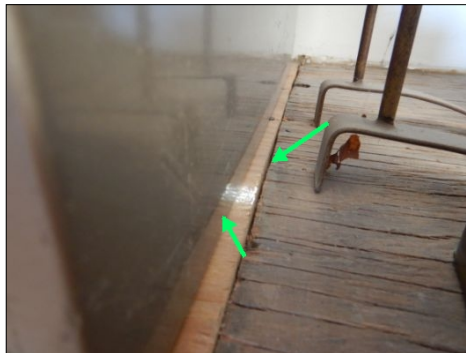
The base of the furnace, or lower plenum, was not adequately sealed. We recommend the base be sealed for more efficient operation and to help prevent combustion products from mixing with circulating air.

Suggest complete review/correction including cost estimate (bids) by a qualified licensed HVAC contractor before the end of the contingency period.

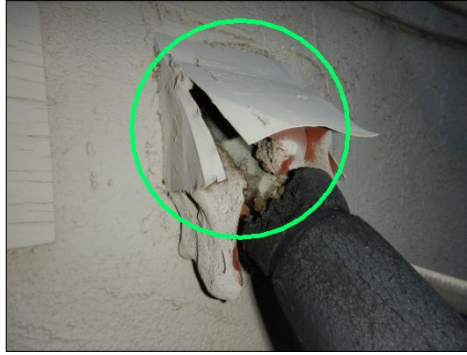
The refrigeration lines are not sealed at the entrance to the house, this will allow pest and rodents to enter the structure, we recommend sealing the lines at the entrance.

Suggest complete review/correction including cost estimate (bids) by a qualified licensed HVAC contractor before the end of the contingency period.

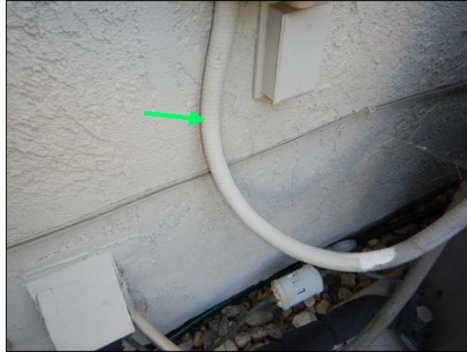
Unsecured conduit was noted at the condenser unit. We recommend that it be secured in accordance with present standards.

Suggest complete review/correction including cost estimate (bids) by a qualified licensed electrical contractor before the end of the contingency period.

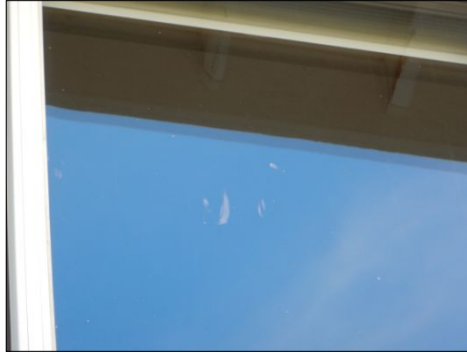
Low E (emissivity) glass is a coating put on the surfaces of the glass to save energy, either by keeping the sun out of the home in the summer or keeping the warmth of home from radiating out of the home in the winter. A number of windows show signs of failure, as the degradation progresses the spots will multiply until eventually there will be complete opaque areas within the window which may have an iridescent tint. There is no remedy to this occurrence and the thermopane(s) will eventually have to be replaced.

Suggest complete review/correction including cost estimate (bids) by a qualified licensed window contractor before the end of the contingency period.

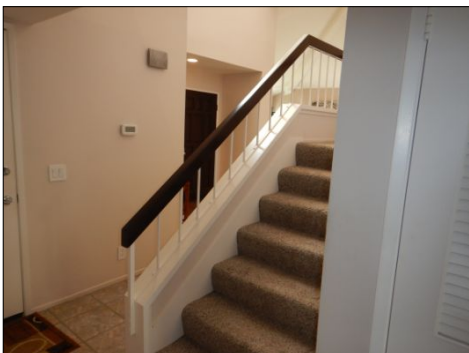
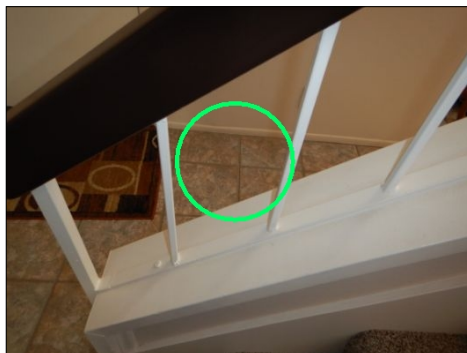
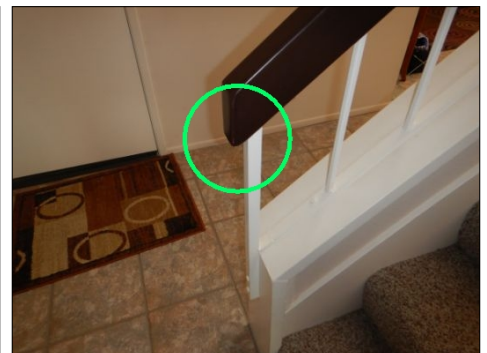
The stair railing configuration is climbable and considered a safety hazard for small children, for increased safety we recommend the railings be reconfigured.

Suggest complete review/correction including cost estimate (bids) by a qualified licensed contractor before the end of the contingency period.

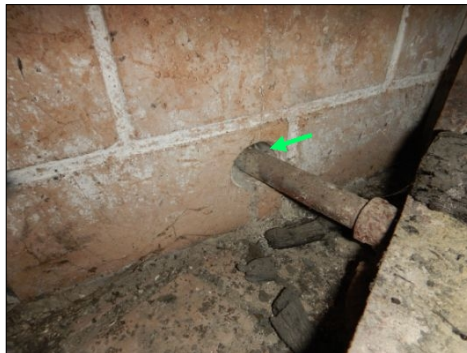
The gas line entry at the family room firebox was not sealed between the gas pipe and the sidewall of the hearth. This seal should be supplied and maintained to prevent the passage of heat and smoke into the wood framed wall.

Suggest complete review/correction including cost estimate (bids) by a qualified licensed chimney contractor before the end of the contingency period.

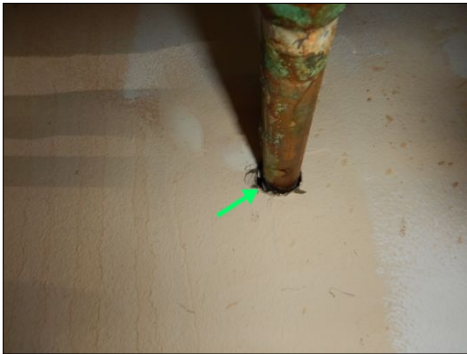
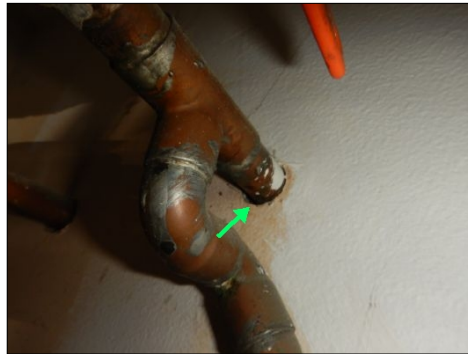
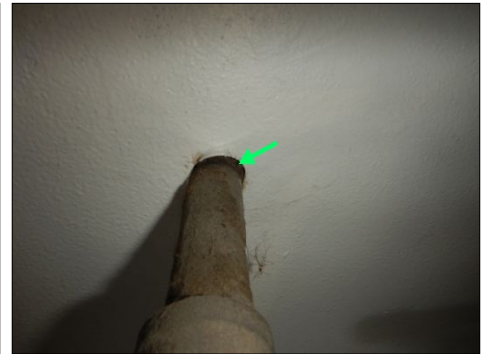
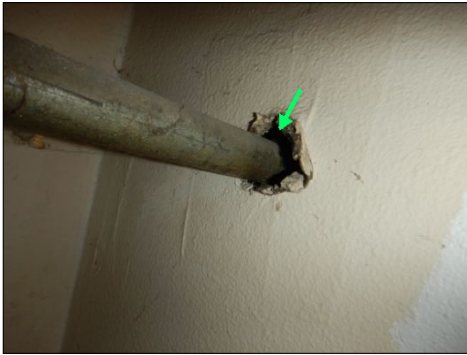
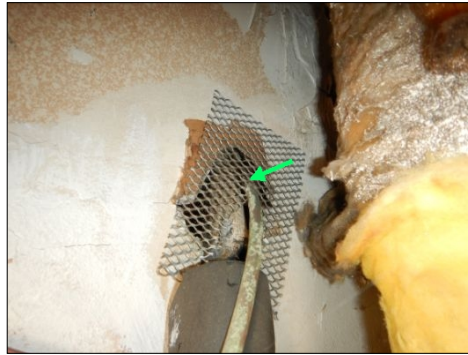
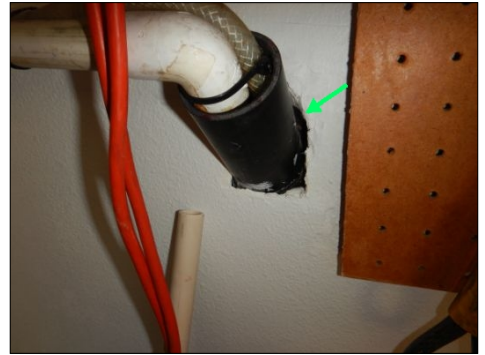
There are unsealed penetrations in the garage separation wall, all penetrations need to be sealed to help prevent the passage of fire.

Suggest complete review/correction including cost estimate (bids) by a qualified licensed contractor before the end of the contingency period.

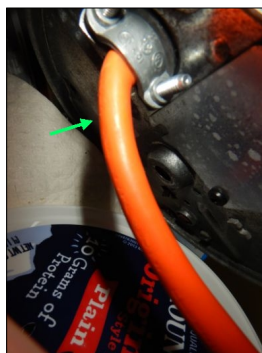
We found extension cord wiring in use at the disposal. This type of wiring is easy to overload and can be easily damaged. We recommend it be replaced with an approved appliance cord.

Suggest complete review/correction including cost estimate (bids) by a qualified licensed contractor before the end of the contingency period.

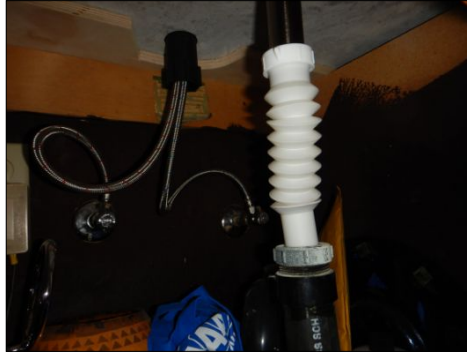
The sink was slow draining in the master bathroom, we recommend cleaning the trap, if the problem persists, a licensed plumber should be contacted for further evaluation and correction.

Suggest complete review/correction including cost estimate (bids) by a qualified licensed plumbing contractor before the end of the contingency period.

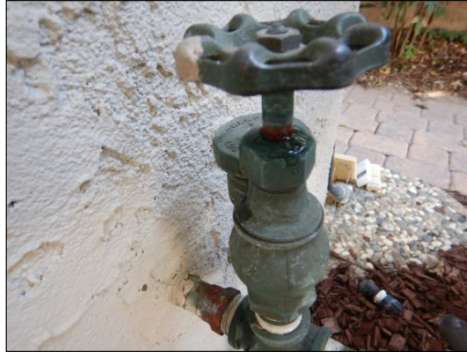
Consideration should be given to installing an automatic control device the fill valve to help maintain the water level in the pool.

Suggest complete review/correction including cost estimate (bids) by a qualified licensed pool contractor before the end of the contingency period.

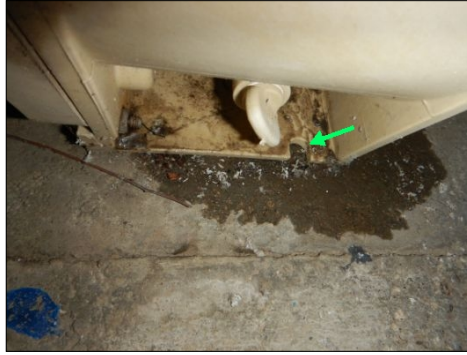
The pump operated when tested. Your attention is directed to the items noted.

Suggest complete review/correction including cost estimate (bids) by a qualified licensed pool contractor before the end of the contingency period.
